The influence of recreational load on the anti-erosion properties of the soils of park stands

Volodymyr Maliuha, Victoriia Minder*, Oleksandr Sovakov

National University of Life and Environmental Sciences of Ukraine
03041, 15 Heroiv Oborony, Kyiv, Ukraine

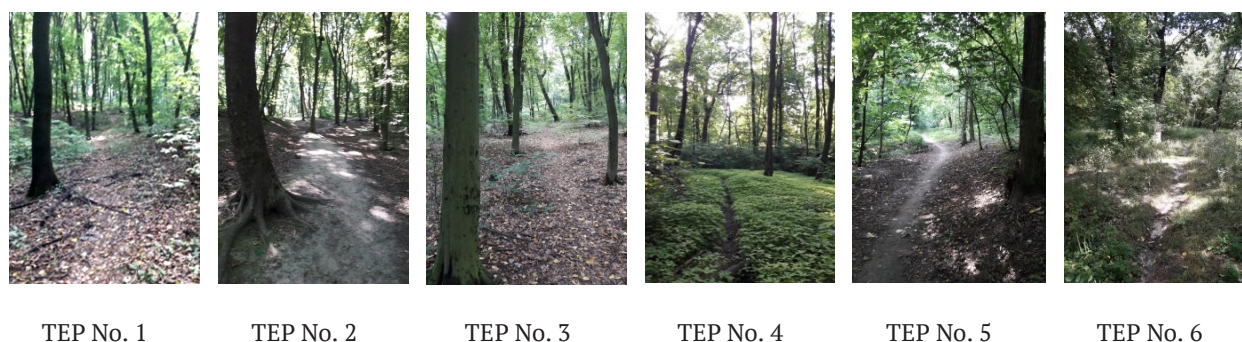
Figure 2. General view of the test network of park stands on temporary experimental plots

and a stocking of 0.5-0.7 (Fig. 2). According to the method of I.D. Rodichkin [17], they form landscapes of closed (TEP No. 1-3, 5) and semi-open (TEP No. 4, 6) types of spaces.

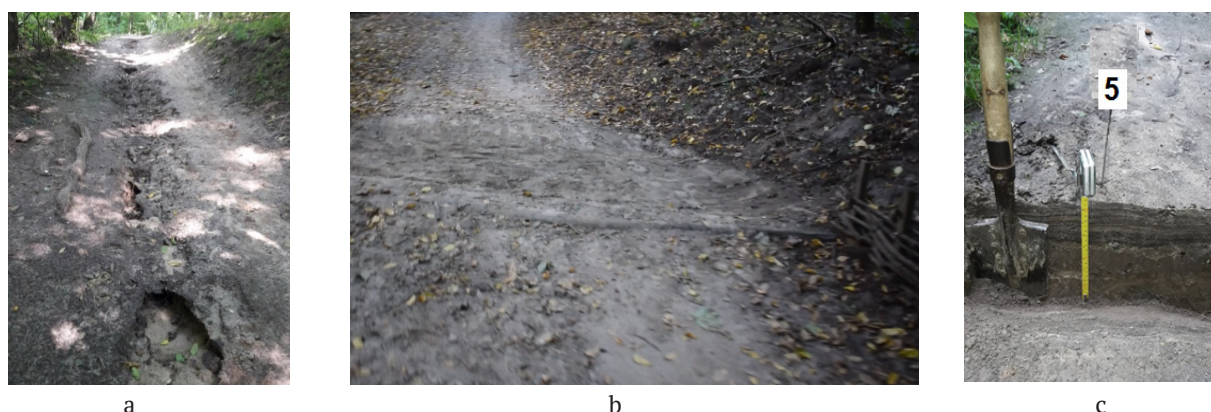
Figure 4. Characteristic erosion processes on park paths were identified: a – linear erosion; b – scum on the drain sprayer; c – the thickness of washed soil for 2021-2022

The most frequent and largest washouts occur on intensively used tests that are located on the slopes of complex landforms. This applies to the areas where concentrated surface runoff is formed under the canopy of liquefied vegetation, as well as in places where the transit part of the runoff coming from roadways reaches them (Fig. 4a).

In 2017, runoff sprinklers were installed at TEP No. 5 to protect the path from erosion and silt retention (Fig. 4b). In 2020, the operation of drain sprinklers was studied. During the three years of operation of one of the sprinklers (2018-2020), it retained 1.5 m³ of silt. The total thickness of the washed soil layers during this period was 20 cm, and their number was 18 pieces (Fig. 4c). Maintenance work was carried out to remove silt for uninterrupted operation of the drain sprayer. During the next period (2021-2022), the thickness of the washed soil layer was 9 cm (Fig. 4c). Such a difference is related to the number and intensity of downpours in the specified periods. Therefore, for the effective operation of a simple hydraulic structure – a drain sprinkler, it is necessary to carry out constant monitoring and maintenance, and if necessary, in cases of damage by recreationists, to carry out repairs.
